**Impact of Water Logging in South Western Coastal Zone of Bangladesh:  
A Case Study**

A thesis submitted in partial fulfillment of the requirements for the degree of Master of  
Science in Civil Engineering at the Department of Civil Engineering

Khulna University of Engineering & Technology

**April 2019**

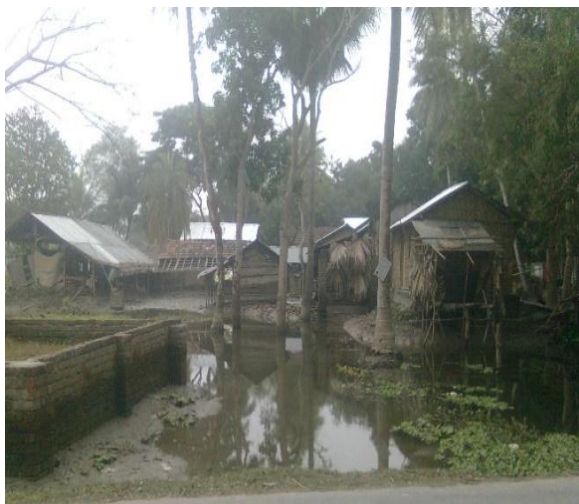
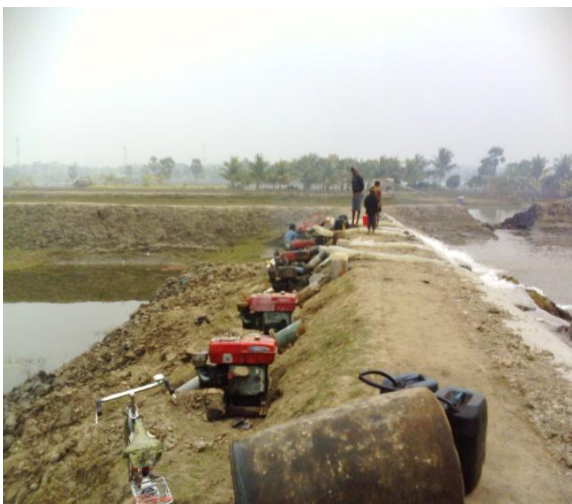
Figure 2.2: Water logging in the study area, 2012

Water logging problem is the common phenomena of the study area for last decade. During the flooding time the people of the area faces many problems. The following Figures 2.2-2.4 shows some real pictures of the water logging of the study area during year 2012, 2014, and 2016 respectively.

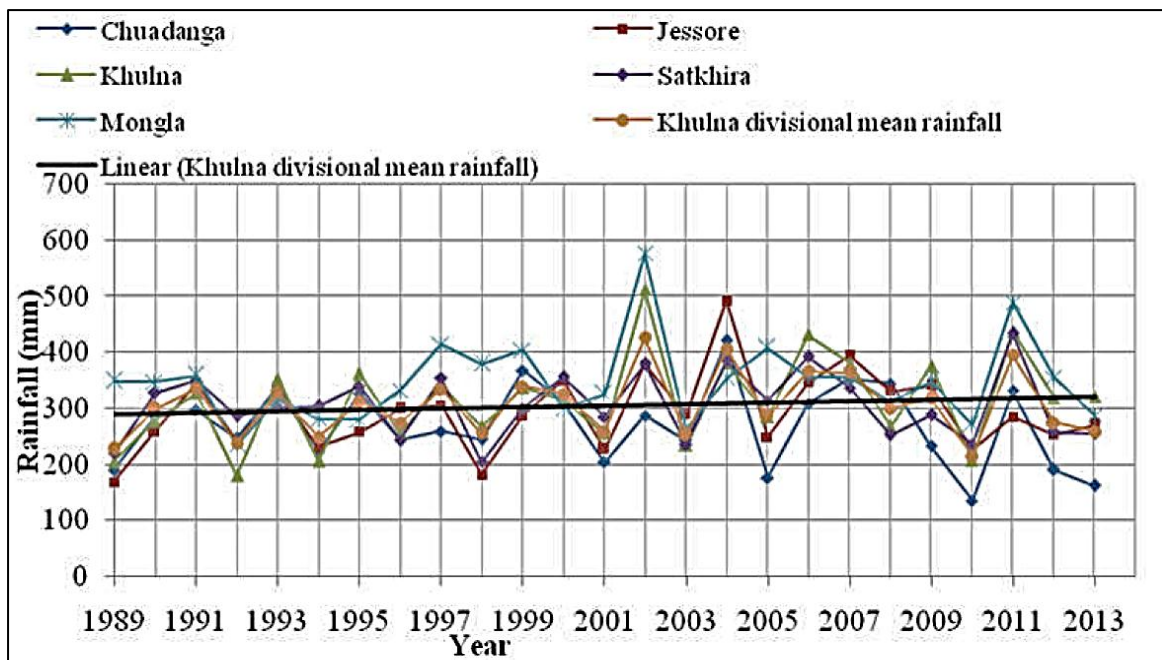
Figure 5.2: Time series of monsoon mean rainfall, during 1989 to 2013.

As Bangladesh is a tropical country and located on the extensive floodplains of the Ganges and Brahmaputra. The Himalayas stands to the north-east of the country and the Bay of Bengal lies on the south of the country. As a result heavy downpour occurs on the country, especially in the coastal areas of our country. In recent years the study area has been exposed to water logging due to heavy rainfall and drainage congestion. In the monsoon relatively low intensity of rainfall also causes serious water logging problems and inundated for several month mainly due to the drainage congestion of the Kobadak river. The Figure 5.2 shows the monsoon rainfall of the study area within Khulna Division during 1989-2013.

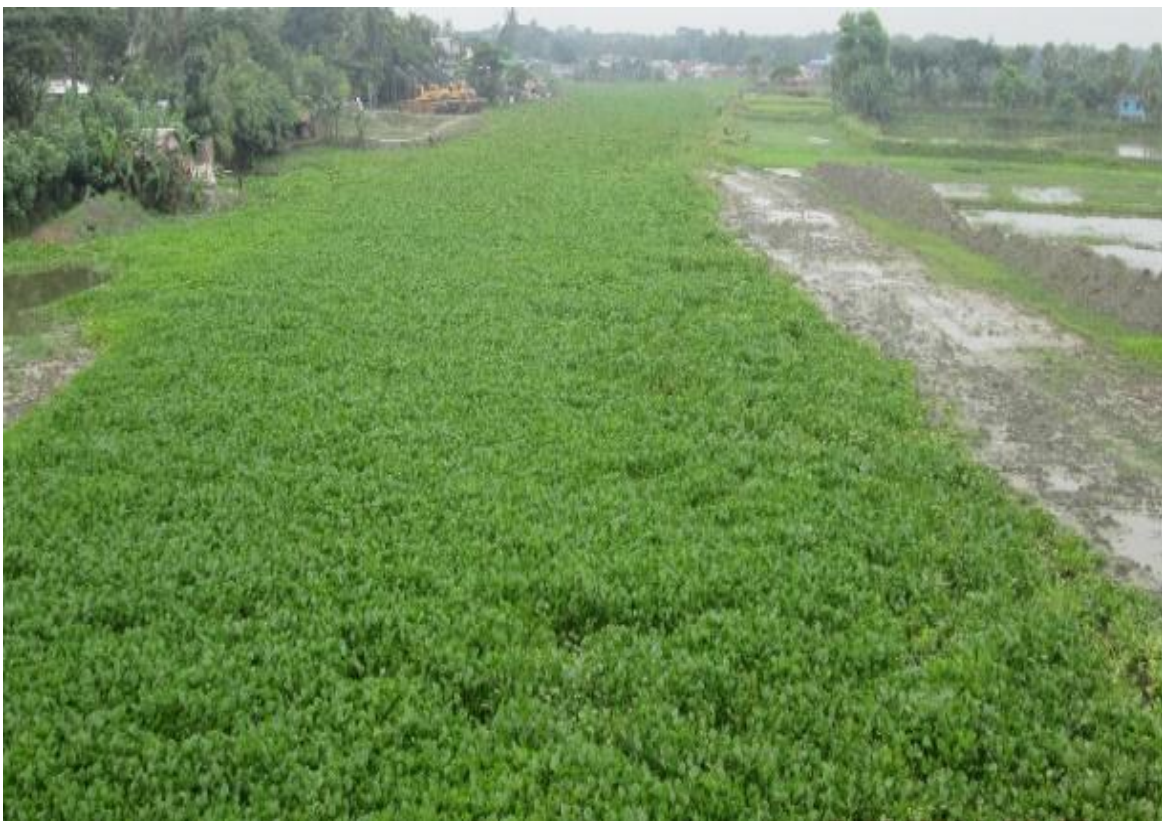
Figure 5.3: Vegetation of the river Kobadak

Rapid population growth and unplanned development, unplanned land filling to develop new residential areas, uncontrolled and haphazard disposal of solid wastes and garbage into the existing drainage system, canals and rivers with unauthorized construction are the summarized general manmade physical and social activities related to the desertion of natural drainage system. The upstream flow of the main river has been blocked due to construction of Farakkha Dam. There is no sufficient flow in the river, therefore the vegetation comes with the rain water and stay on surface. Figure 5.3 shows the vegetation of the drainage systems of the study area. These vegetation create obstacle to the flow through the drainage canals and help to water logging in the surrounding.

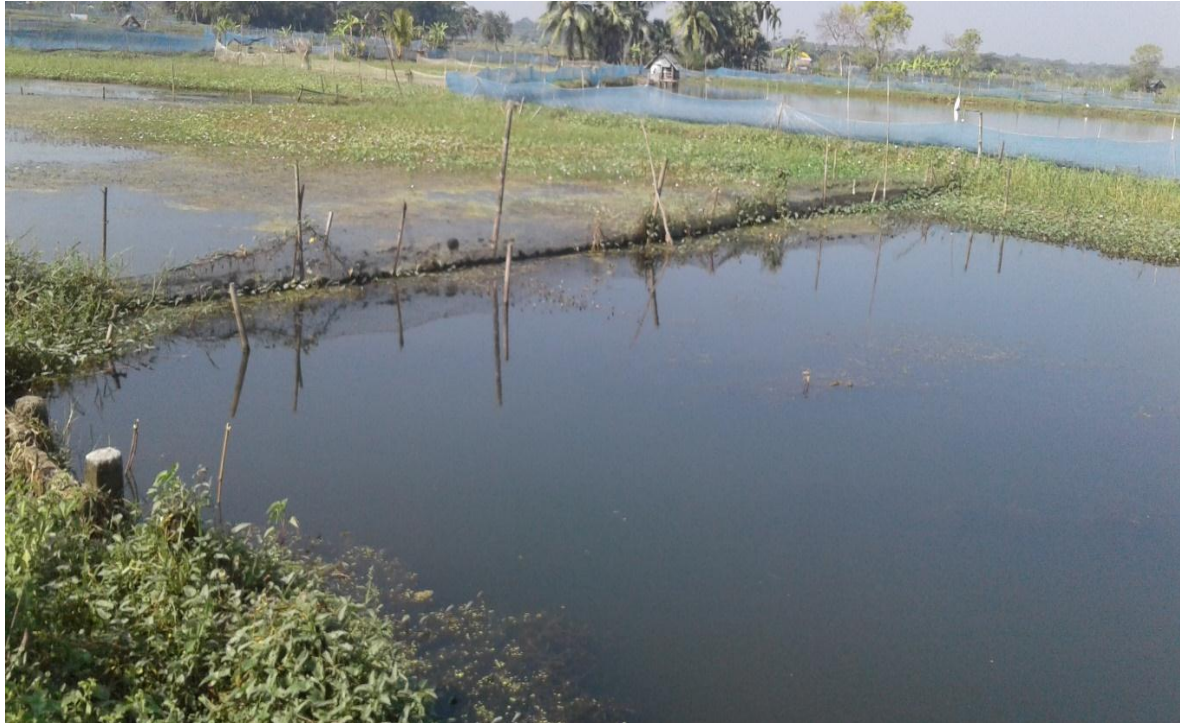
Figure 5.4: Blockage of drainage network due to fish culture.

drainage problem to the upstream. From the field investigation Figure 5.4 shows the drainage system blockage by fish culture.

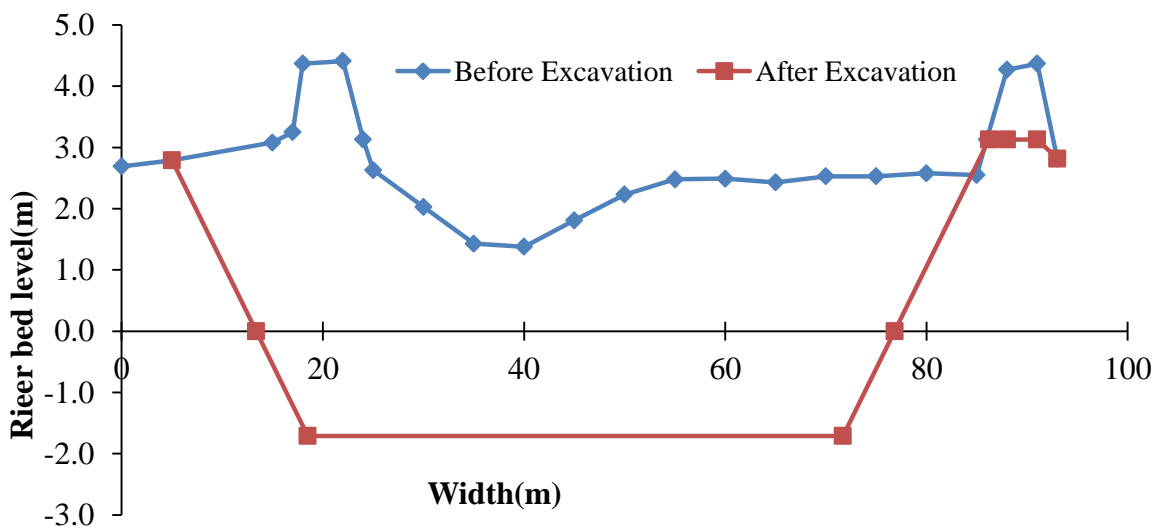
Figure 5.5: Actual and proposed section of Kobadak river for Emergency Rehabilitation works of Cyclone AILA Damages during the year 2009-2010.

The drainage capacity of the river has been reduced by siltation of the river. A land survey work was performed during the implementation of the Emergency Rehabilitation Works of Cyclone AILA Damages during the year 2009-2010 shows in the following Figure 5.5.

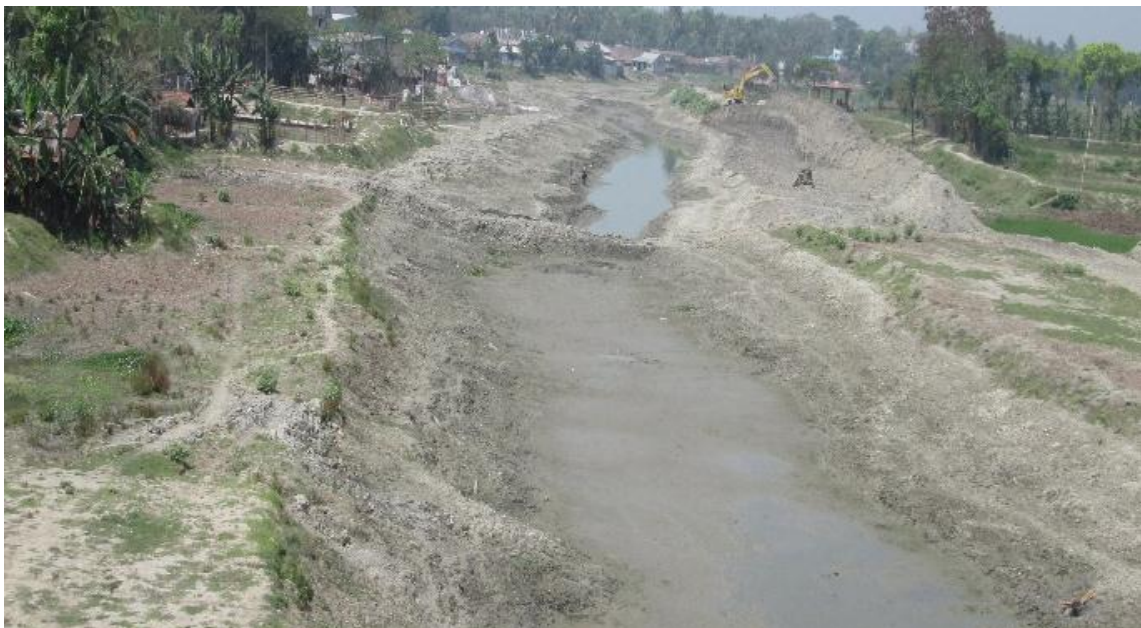
Figure 5.6: Siltation of Kobadak river

The river Kobadak is one of the tidal river of Bangladesh and it is link with the Bay-of Bengal passing through the Sundarban. When the high tide comes then much amount of silted material brings to the river deposited to the river bed, canals and low lands of the study area. Following Figure 5.6 illustrates that the main natural drainage system of the study area lost its runoff capacity and increased impervious area due to siltation.

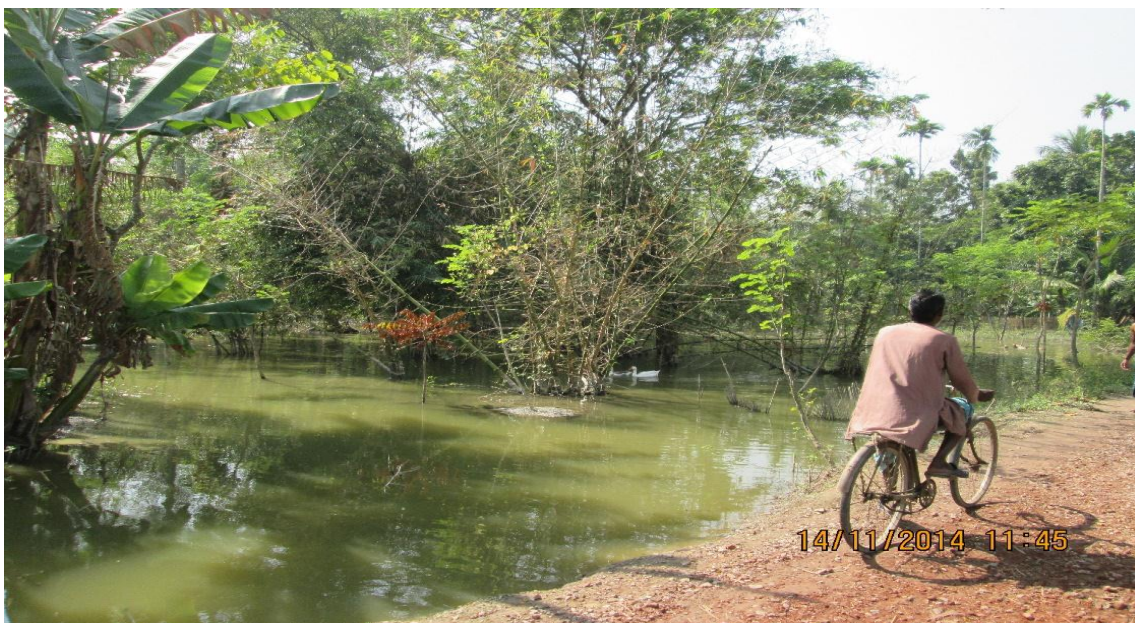
Figure 5.8: Pukka road damaged due to water logging in the study area

Water logging of the ground contributes to subsidence, dampness and other damage of property. Water logging causes the damage to roads (both pukka and earthen) especially in the rainy season of every year. It leads to the movement problem and interrupts the journey of that area. Figure 5.8 illustrates that road in the study area severely damaged due to water logging.

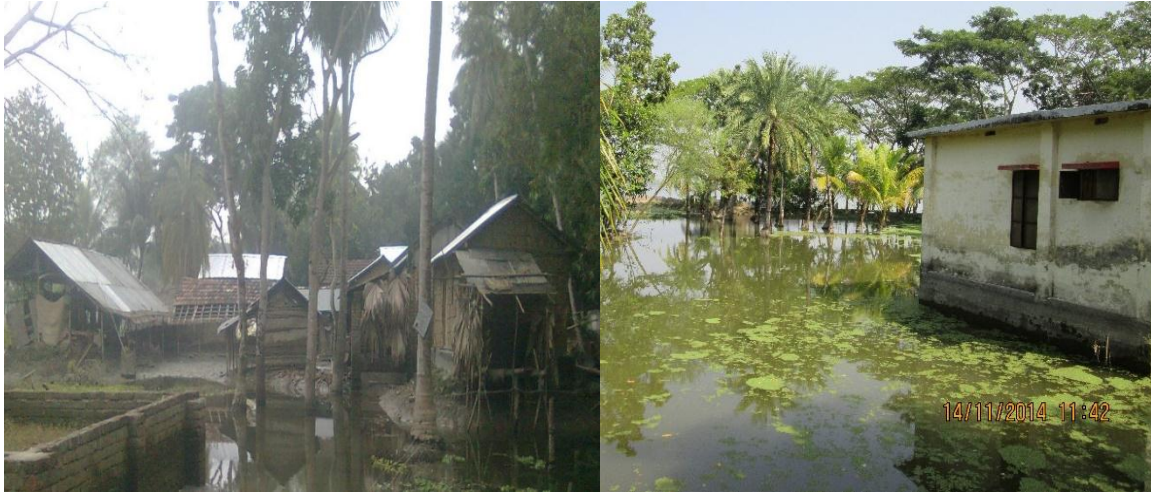
Figure 5.9: Damages of structure for water logging in the study area

the longevity of katcha houses. Figure 5.9 shows that the wall of the building has been affected due to the water logging and the katcha houses have been destroyed.

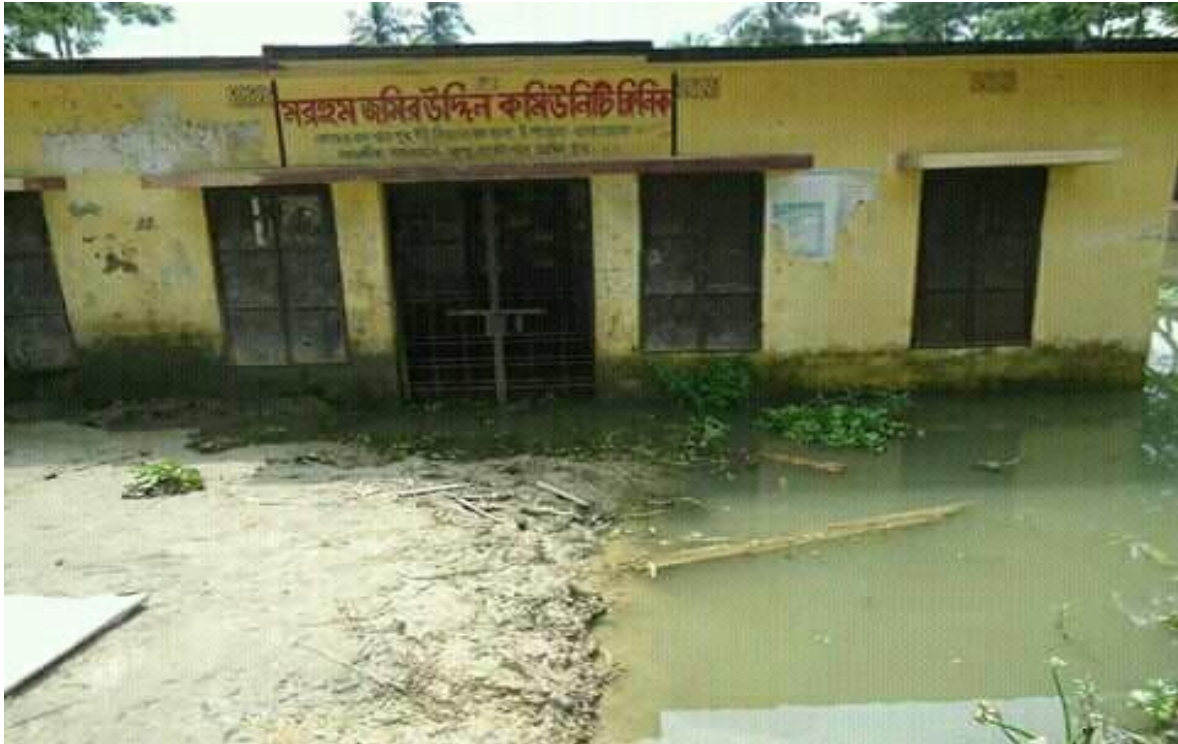
Figure 5.10: Affected community clinic by prolonged water logging in the study area

Water logging has an adverse effect in health sector. As the rural area this effect is more significant than the urban areas. Sometimes, they don't have access to potable water and so had to rely on surface or shallow groundwater sources that are polluted. The rural area communication facilities, health care facilities and other necessary facilities is not sufficient and also during flooding this become more complex to the people. The community clinic play a very important role for primary treatment, pregnancy health care, and other emergency treatment of the rural areas. Figure 5.10 shows that one of the community clinic of the study area has been flooded and not possible to get any service from there.

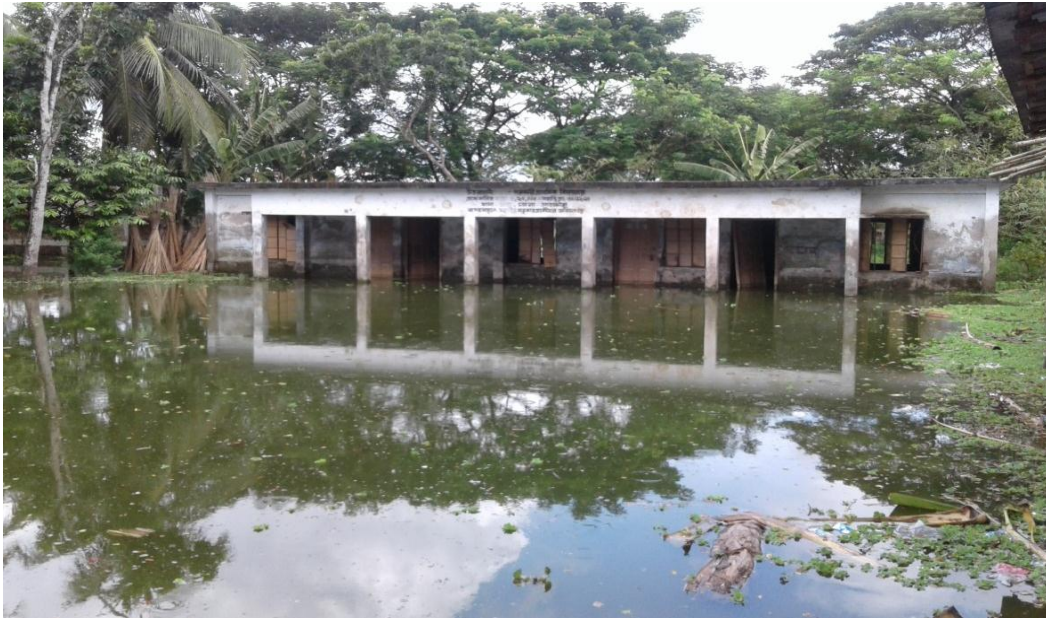
Figure 5.11: Prolonged water logging in the primary school in the study area

Due to prolonged water logging in the educational institution the students can't continue their education normally they involved with some bad practice that creates social problems. Following Figure 5.11 shows the situation one of primary school of the study area affected by water logging. From this picture everybody can realize that what difficulties are facing in the field of education in the selected study area.

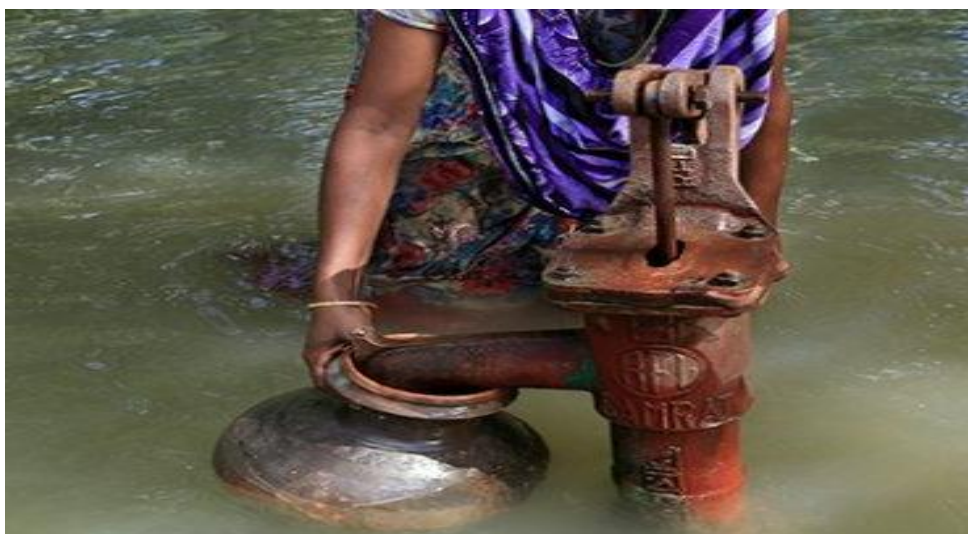
Figure 5.12: Contamination of drinking water source for water logging.

Due to water logging the portable water source become contaminated by the surface water. For this reasons the shortage of drinking water is the common phenomenon of the flooding area. The peoples need to collect the drinking water from market of other sources. Figure 5.12 shows the condition of the drinking water source affected by water logging.

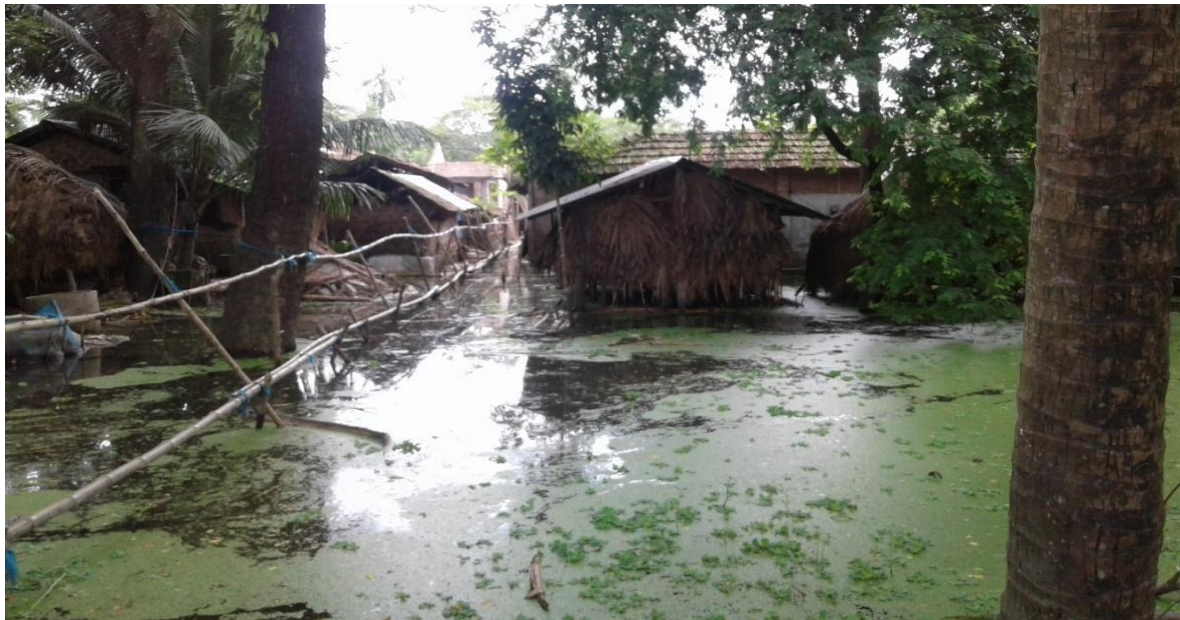
Figure 5.13: Destruction of passage and houses due to water logging of the study area

Water logging damages both of pukka and katcha roads and reduces the life time of the existing various underground utility services such as water, telephone, sewerage etc. It needs a huge cost to replace these facilities and increases the maintenance cost for the authority. Damage to substructure, brick foundations, katcha houses in slums and low-income areas due to water logging means the huge economic losses for the inhabitants. Figure 5.13 shows the condition of affected road and houses due to water logging. This figure indicates that the most of the houses and road communication facility must be reconstructed again that has the direct impact on economy.

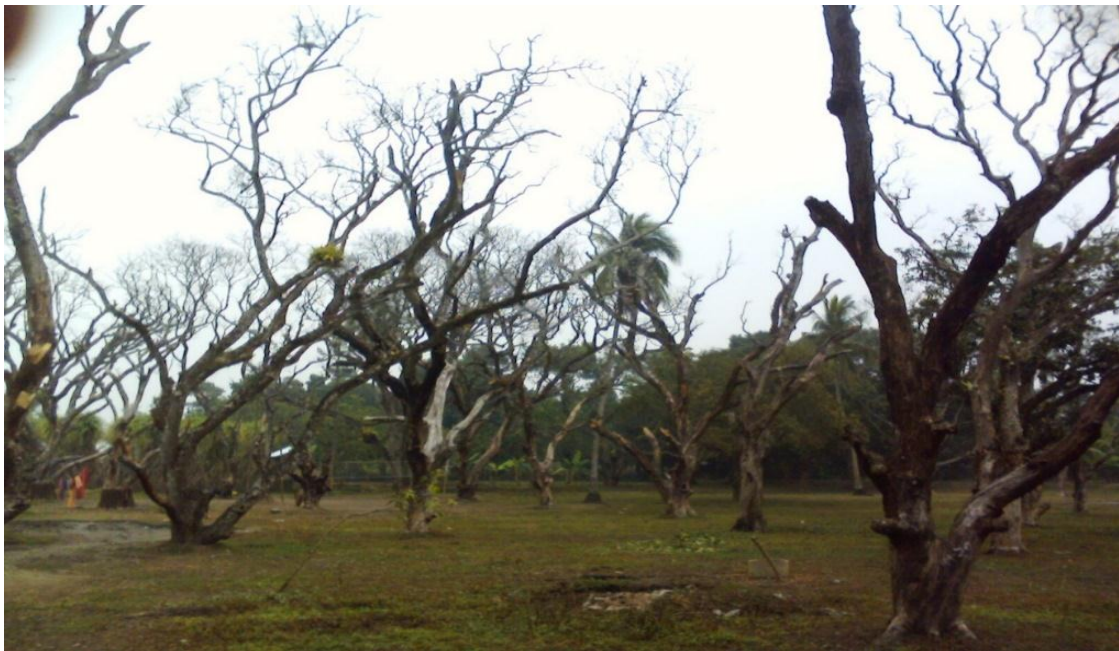
In the earlier the study area was free from flooding and different types of trees were grown. Water logging affects the plants life and depleting many of them due to prolonged water logging of the study area. Figure 5.14 shows the injured trees in the study area due to prolonged water logging. Due to depleting of trees of the locality the economy as well as the ecosystem can be destroyed.

Figure 5.14: Depleting of plant due to water logging in the study area

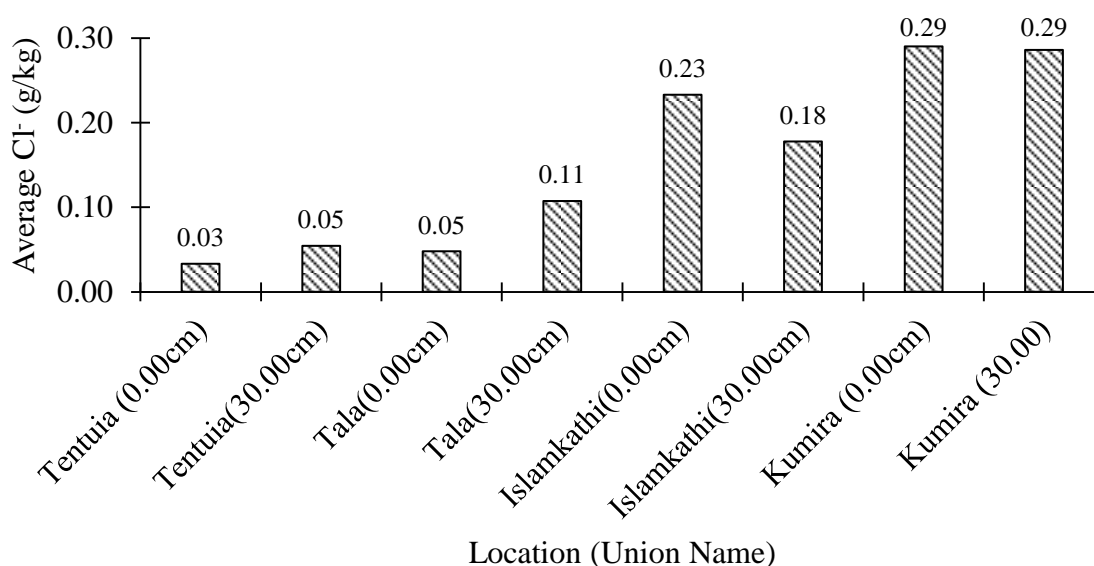
Figure 5.22: Chloride concentrations of soil sample at different location of the study area

Chloride concentration is one of the important component for both of soil and water for ecosystem. Although chloride is essential to plants in very low amounts, it can cause toxicity to sensitive crops at high concentrations. By investigation of the soil samples it has found that the maximum chloride concentration was 0.08g/kg, 0.315g/kg, 0.356g/kg and 0.490g/kg of Tentulia union, Tala union, Islamkathi union and Kumira respectively. The Figure 5.22 and Table 5.12 shows the chloride concentration of the soil samples at different time of the study area. From the figure it is shown that the chloride concentration become higher in the month of May and November for the Islamkathi and Kumira union because this area is closed to the river Kobadak.

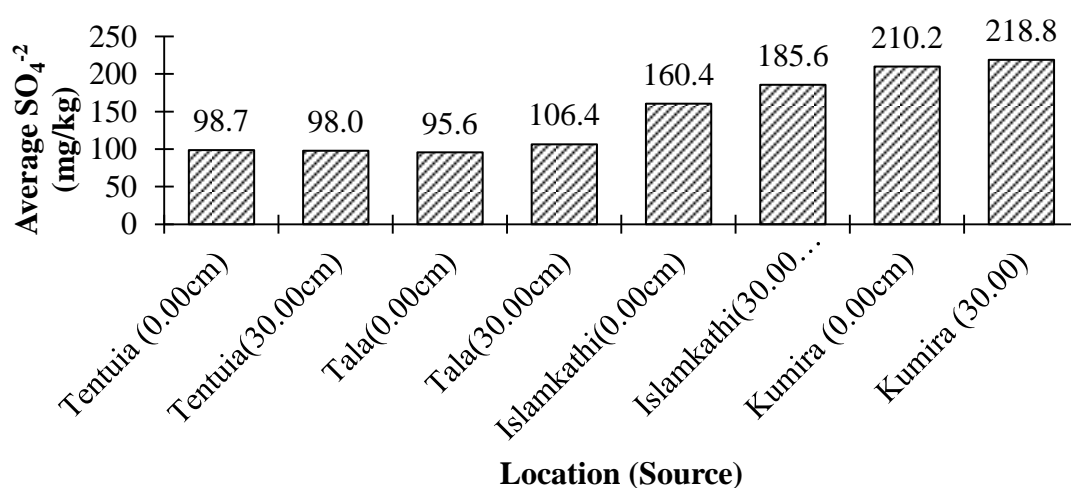
Figure 5.24:  $\text{SO}_4^{-2}$  of soil sample at different location of the study area

The following Figure 5.24 shows the average value of soluble sulfate ( $\text{SO}_4^{-2}$ ) concentration of the study area at different location of the study area.

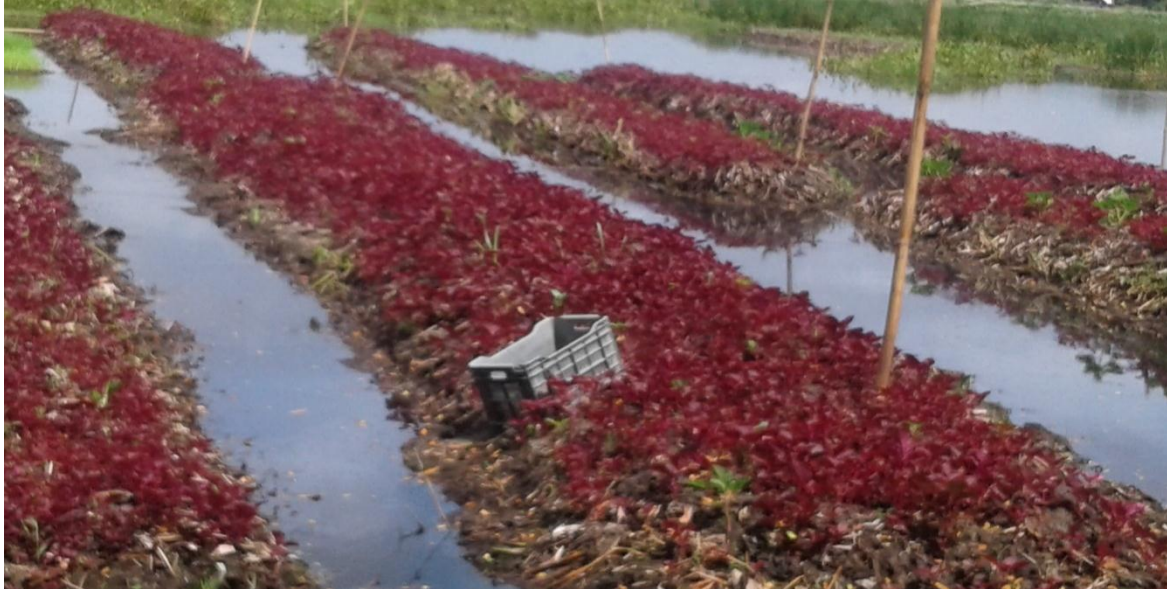
- **Crops and Plants:** Emphasis needs to grow the salt and water tolerant varieties crop and plants also for period of cultivation, short maturing varieties, fertilizer and soil fertility management system. Figure 5.31 shows the floating crop cultivation system;

Figure 5.31: Floating crop cultivation during water logging.
